**Attachment A: Image of visible differences of Lakewood bag and Costa Rica bag**

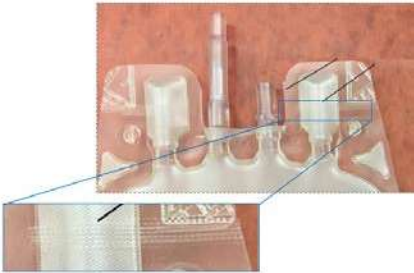
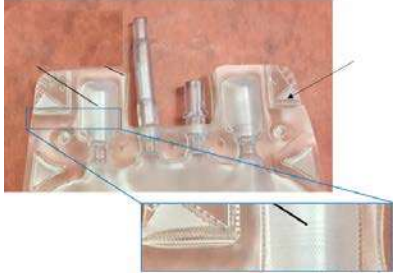
Difference	Lakewood bag	Costa Rica bag
90degree rotation of Vinyl Orientation

<p data-bbox="735 615 1154 669">Blue arrow: Direction of Vinyl Growth Red arrow: Direction of Vinyl Shrinkage</p>
Easy open score lines are less visually apparent due to type of cutting blade used.

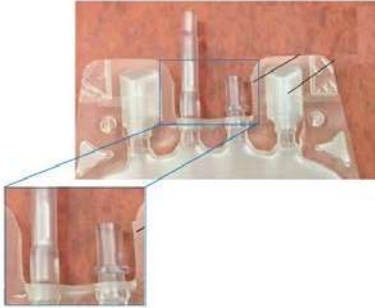
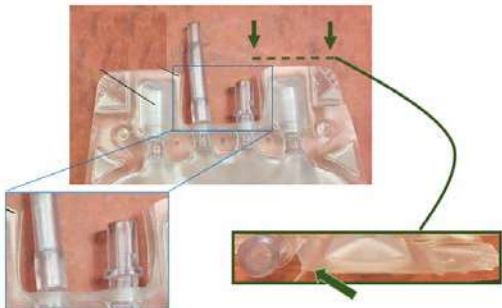
Unwelded skirt appearance in the port area
